# Evaluation Report 292

## Leon 8200 (12.3 m) Rod Weeder

A Co-operative Program Between

## LEON 8200 ROD WEEDER

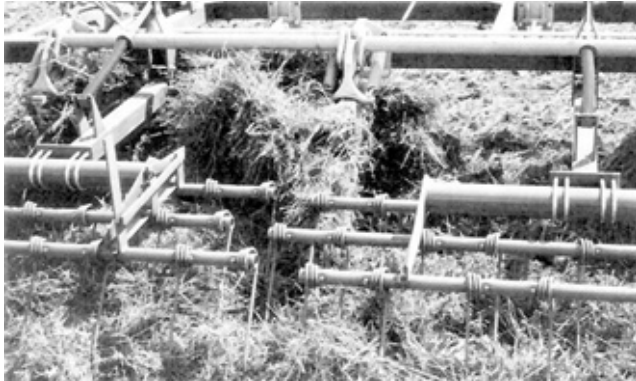
**Plugging:** The Leon 8200 cleared trash well in moderate trash conditions. Occasional plugging occurred at the wheel locations in heavy trash conditions (FIGURE 4).

FIGURE 4. Plugging at the Wing Wheel Location in Heavy Trash.

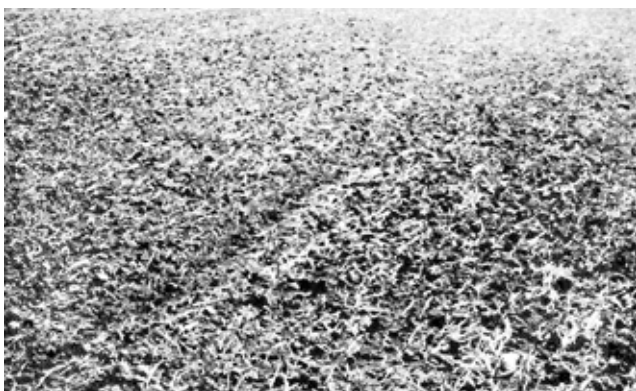
**Trash Burial and Surface Conditions:** The rod drive shanks of the Leon 8200 left deeper furrows than the rod support shanks. These furrows were usually filled in by the finishing harrows resulting in a uniform seedbed (FIGURE 5). The Leon 8200 buried less trash than most cultivators (FIGURE 6).

FIGURE 6. Typical Secondary Tillage With Mounted Harrows and Cultivator Shanks.

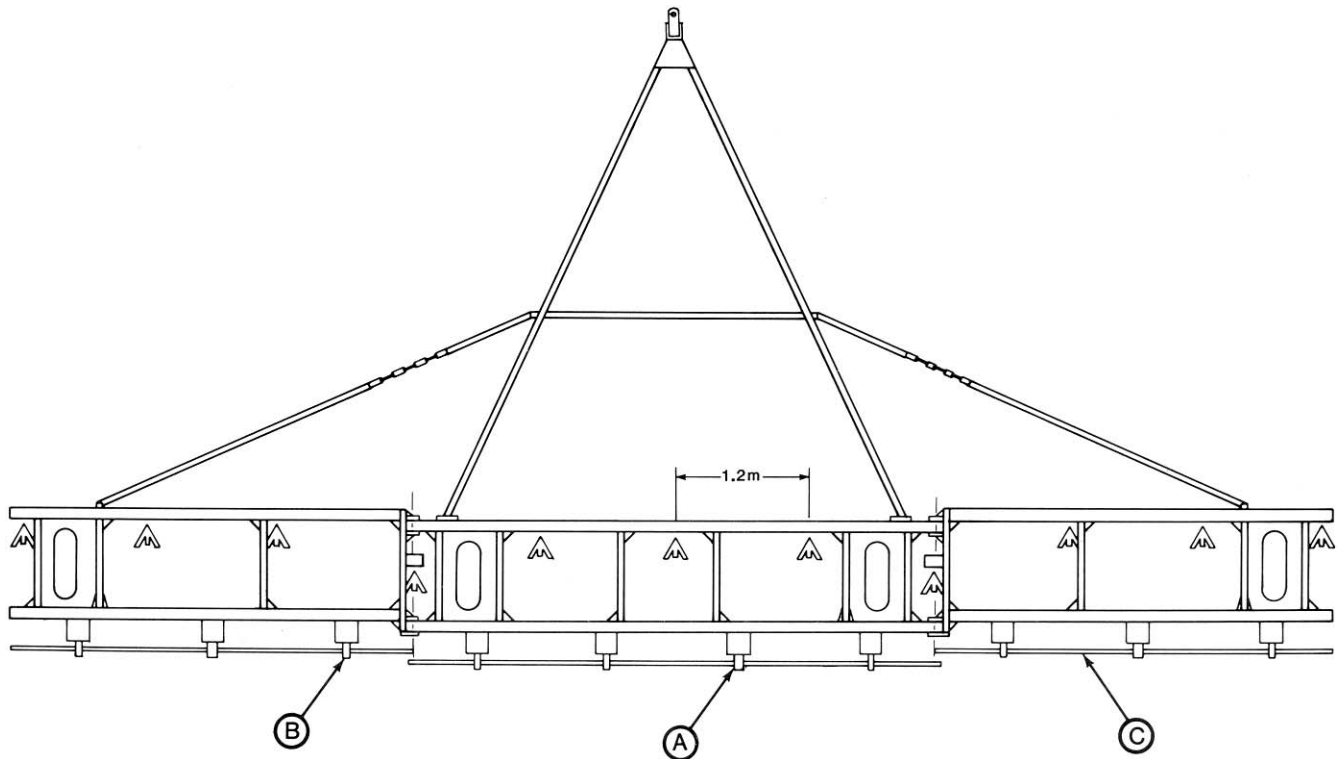
**Skewing and Stability:** The Leon 8200 was stable and sideways skewing only occurred on hillsides. The location of the rod shanks and cultivator shanks (FIGURE 7) did not impose any side forces on the rod weeder during normal tillage.

FIGURE 7. Shank Pattern (A) Rod Drive Shanks, (B) Rod Support Shanks, (C) Rod.

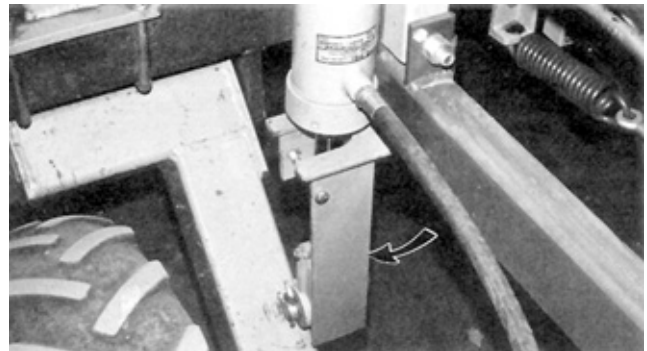
**Transporting:** The Leon 8200 was easily placed into transport position in less than five minutes using the hydraulic wing lift system (FIGURE 8). The retaining straps between the hydraulic cylinders had to be replaced with shorter straps to provide easy installation of the transport lock pins. The transport locks for the depth control wheels on the centre section (FIGURE 9) were large and difficult to install or store when not in use. It is recommended that the manufacturer modify these transport locks to provide easier installation and storage.

FIGURE 9. Transport Depth Control Lock.

5. New depth control transport locks were introduced on 1982 models.
6. We will ensure the bracket for the slow moving vehicle sign is located to provide full visibility of the sign.

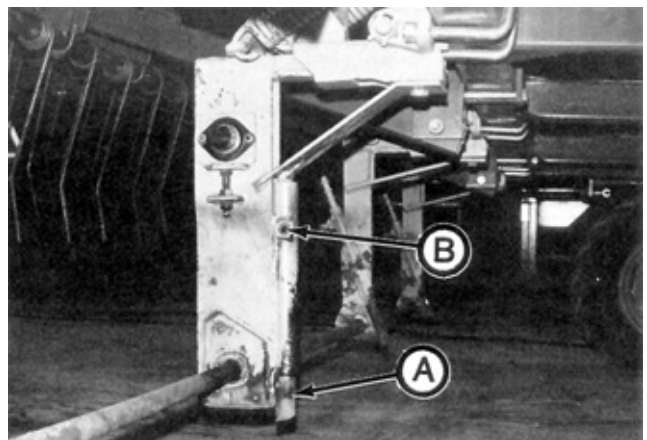
The rod drive shanks penetrated about 75 mm (3 in) deeper than the rod, when the wear rods were properly adjusted. This produced deep furrows behind the rod drive shanks and caused some seedling damage when operating the rod weeder in seeded fields. It is recommended that the manufacturer consider modifications to reduce excessive penetration of the rod drive shanks.

**Rod Shank Wear Rod Adjustment:** The Leon 8200 rod shanks were equipped with adjustable wear rods that required frequent adjustment in abrasive soils. The wear rods on the rod drive shanks were difficult to adjust due to rod binding and limited access to the top of the rods (FIGURE 10).

FIGURE 10. Rod Drive Shank (A) Wear Rod, (B) Set Screw Adjustment.

1. In view of your findings and comments, we will recommend that the wear rods be set no more than 9 to 13 mm (3/8 to 1/2 in) below the drive boot when working seeded land. However, in all other conditions, the present recommended setting should be maintained to minimize drive boot wear.

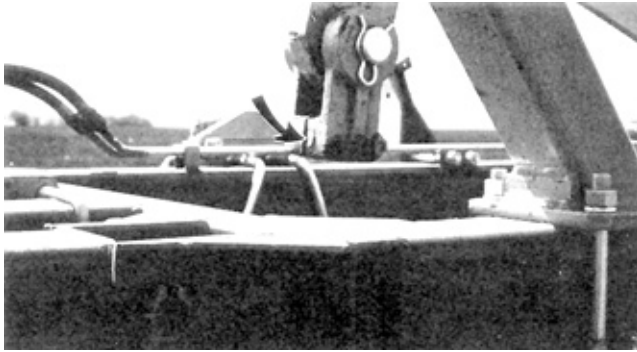
**Hydraulics:** A wing lift cylinder yoke (FIGURE 12) failed when lifting the wings into transport position.

FIGURE 12. Hydraulic Cylinder Yoke Failure.

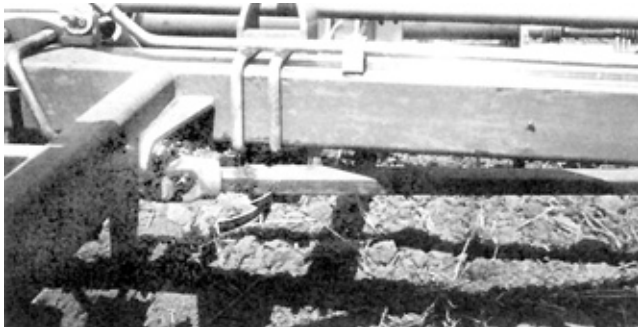
**Frame:** The rod drive shafts interfered with the harrow mounting bolts when the lateral levelling adjustments exceeded the maximum setting stated in the operator's manual. When set at the maximum setting, the rod drive shaft may contact the rod weeder frame if the rod shanks trip to clear obstructions. It is recommended that the manufacturer modify the rod drive assembly to prevent possible damage to the rod drive shaft.

FIGURE 13. Interference of the Frame with the Rod Drive Shaft.

3. The rod drive system was modified on later 1982 machines to provide increased clearance for the rod drive shaft.
4. We recommend that the drive chains be removed for long transport distances only. We feel that removal of two bolts allows easy access to the rod drive chains.

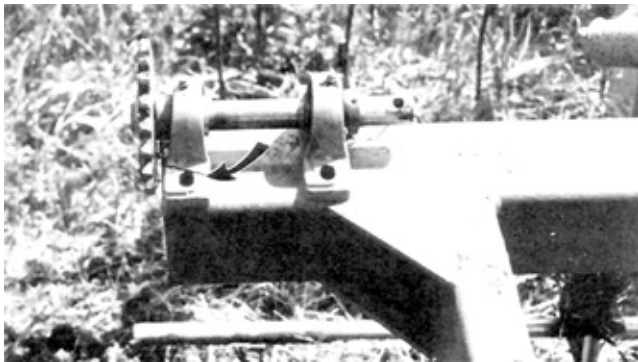
The pillow block for the rod drive shaft failed three times because it was mounted on an uneven surface (FIGURE 14). Shimming the pillow block with washers did not eliminate the problem.

FIGURE 14. Rod Drive Pillow Block Failure.
